Visual Assessment of Cullowhee and Richland Creek to Assess Habitat Quality

Wayne Ryan, Arthur Bien, Andy Myers, Taylor Payne
Department of Biology
Western Carolina University
123 Natural Science Building
Cullowhee, NC 28723 USA

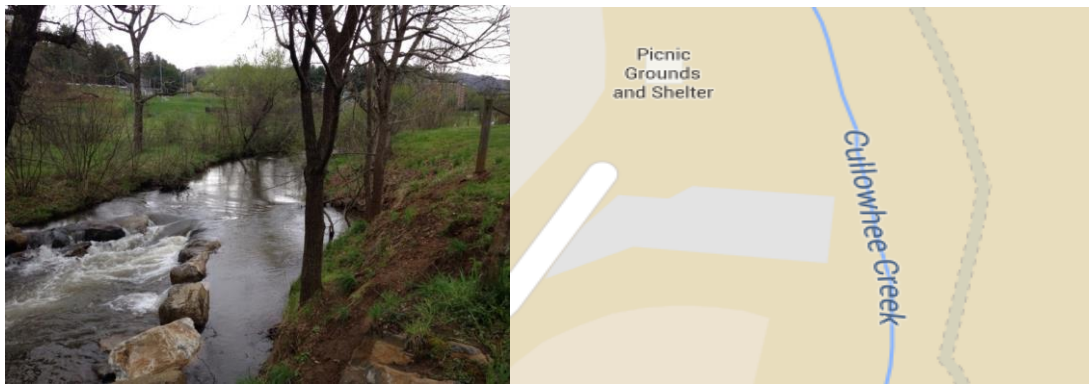
Figure 1. Western Carolina University Park (Urban Downstream Cullowhee Creek) latitude/longitude: 35.310781, -83.185095⁷

This area is where previous restoration efforts to restore the health of the stream occurred. Areas of previous channelization are still present with areas of human activity on either side of the creek apparent. To the left, there is the park, a softball field, and further down a parking lot and to the right there is sports field as well as a track field.

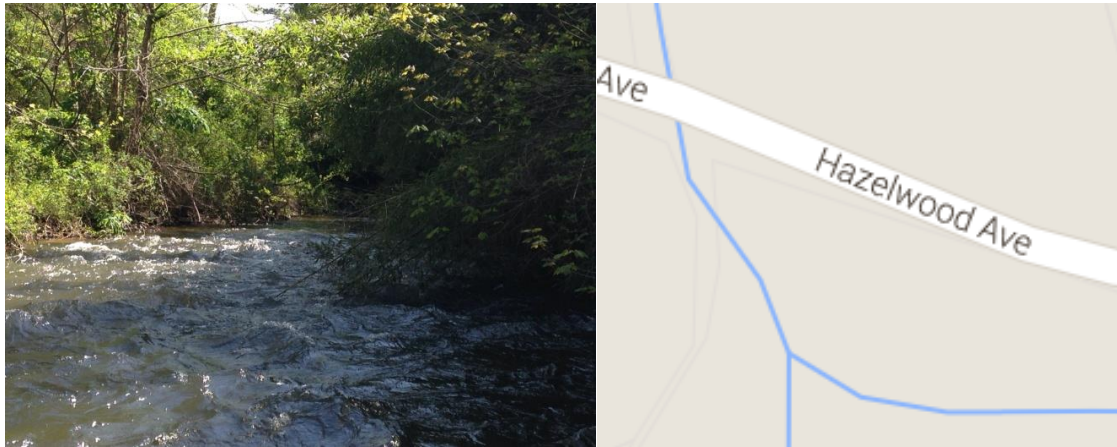
Figure 4. Hazelwood Rd. (Rural Upstream Richland Creek) latitude/longitude: 35.479021, -83.007986⁵

This was one of the healthier sites present in the city of Waynesville. Both sides of the bank were heavily vegetated with little to no human impact overall. There was a fast flow of water present with no areas of slow moving water present in the entire 100m pass.
