## **Vibration Serviceability of Monumental Stairs**

Amber Jurgensen  
Architecture  
Virginia Tech  
Virginia Polytechnic Institute and State University  
Blacksburg, Virginia 24061 USA

Faculty Advisor: Dr. Mehdi Setareh

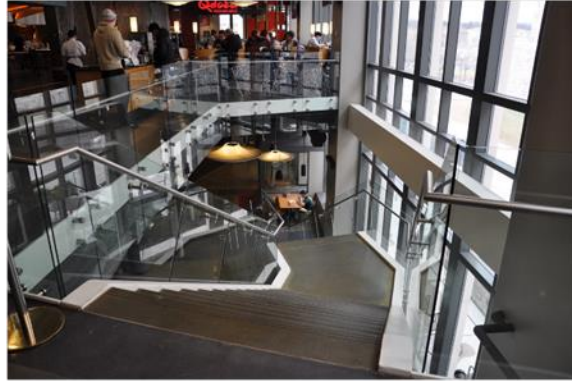
Figure 1 shows the monumental stair at Lavery Hall. It connects the ground floor to the second level of the building located in the dining hall area. It is a steel structure with a 4,000 psi concrete composite deck. The guardrail is made of glass. Stair treads are precast concrete bolted to a steel plate, which is welded to the steel stringers.

Figure 1. photo of Lavery Hall staircase

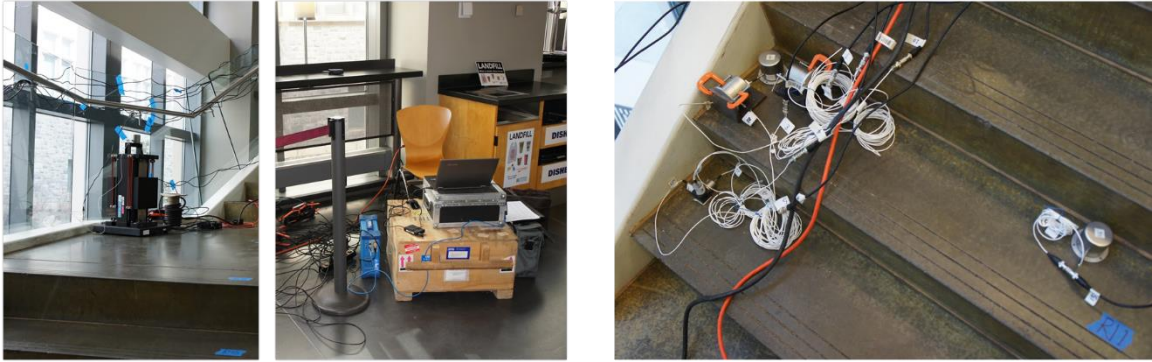
A modal test of the stair was conducted to estimate its natural frequencies and mode shapes. An electrodynamic shaker that excited the stair within a frequency band, in conjunction with accelerometers which read the acceleration of the structure at many points were used (Figure 4). The acceleration for all of the frequencies are recorded onto the computer and saved for further modal analysis to estimate the natural frequencies, mode shapes, and damping ratios.

Figure 4. shaker, computer, and accelerometers used to test stair

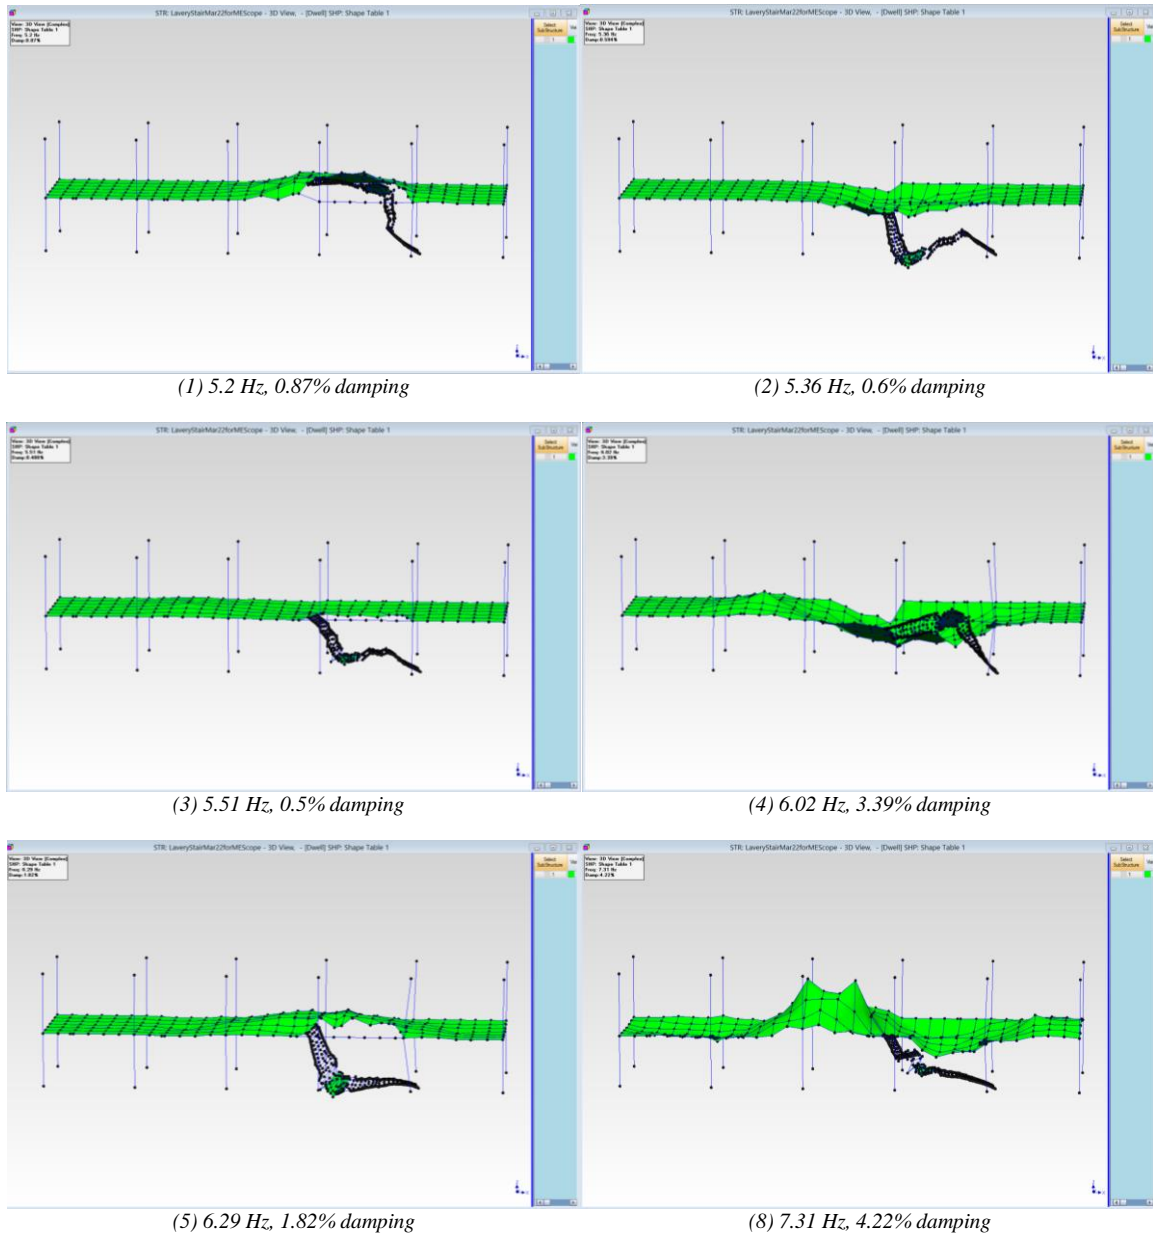
Using the curve-fitting feature of the software, eight modes of the structure were identified along with their associated natural frequencies and damping ratios as shown in Figure 6.

Figure 6. ME'scope animated mode shapes

The measured and computed natural frequencies based on the updated model are shown in Table 1 along with their percentage differences. As can be noted, the maximum difference is less than 6%. Therefore, the structural analysis model is successful in its accuracy to predict the natural frequencies. Mode shapes were compared visually to check that the computed and measured natural frequencies resembled each other.

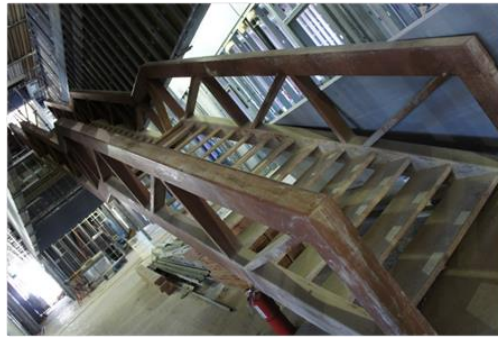
Figure 9 shows the monumental stair at the VT Classroom Building. It connects the ground floor to the third level of the building. It is a steel structure with a concrete composite deck, containing a 6 inch foam EPS layer and concrete topping. Here, the guardrail is part of the structural system. Stair treads are a metal pan filled with concrete, which is field welded to the steel stringers.

Figure 9. photo of VT Classroom staircase
